ATTACHMENT A
Burn Building Grant Application
Construction, Renovation, or Repair

Field Report

Subject: Repair Limited and Selected Areas of the Alexandria Fire Department Burn Building
per the The Structures Group Report and the job walks with Captain Jason Wehmeyer

Project Title: AFD-13-RFQ-002 Alexandria Fire Department Burn Building Repairs

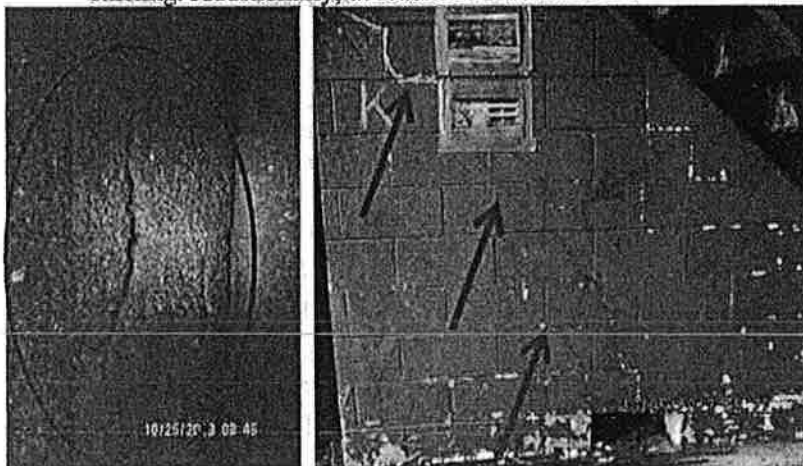
1. Some concrete masonry unit (CMU) walls are cracked and blocks have shifted. These walls are not load bearing, but during active water exercises, the cracks and shifted block will allow water to seep into the CMU and further deteriorating the structure. During freezing periods, the water within these blocks may freeze causing more cracks and wall shifting. Additionally, at least one lintel above a window was cracked.

- Repair the damaged masonry wall sections
 - Remove and replace broken concrete masonry units (CMU)
 - Remove CMU that are out-of-level
 - Plum exterior walls
 - Cracked mortar joints
 - Infill exterior doors being replaced
- Perform the necessary heat tile maintenance to the System 203, and/or 203 Lite, thermal lining system(s)
 - Included as part of the maintenance tightening the system and refilling bolt hole packing, and repacking joints that are filled with cast in place refractory mortar. Tile and insulation is not included.
- Repair the cracks in the concrete floor beneath the heat tiles
 - Cracks in the concrete floor of Room 202 be routed and sealed
 - Install a setting bed be installed below new fire pavers to achieve drainage in that room
 - The new fire pavers would be medium duty and would measure 4.5" x 9" x 1.25"

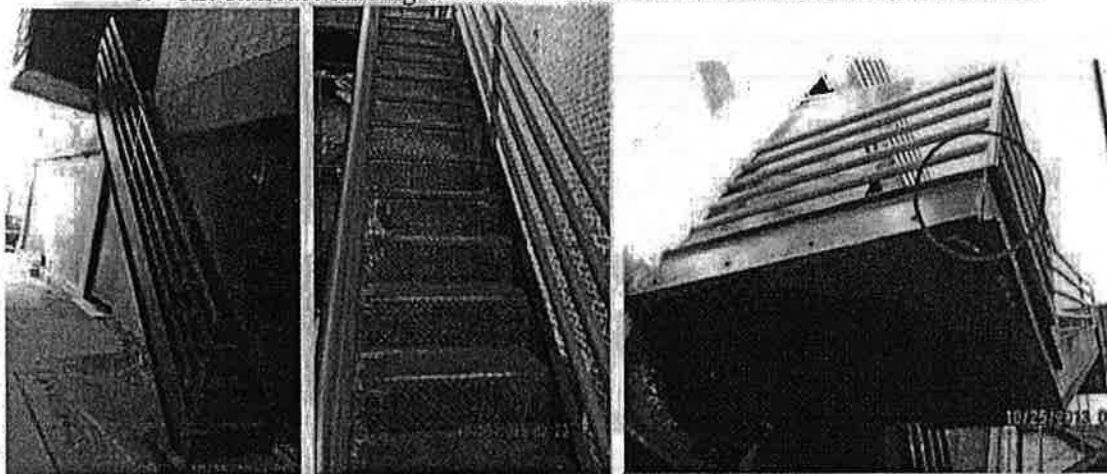
2. The outside staircase is narrow and has diamond plate for stairs.
 - a. During a training exercise where the fire fighters are wearing gear, the narrow steps make it difficult to climb, and could pose a movement impedance problem.
 - b. The diamond plate on the steps allows water to accumulate creating a potential slipping hazard especially in the winter months.
 - c. The staircase landing C-channels are exfoliated and deformed at the corners.

- Repair the damaged railing sections along the upper decks and paint
- Remove the existing outside staircase and replace with a wider steel staircase to the first floor only.
- Remove the existing inside front staircase and replace with a steel.
- Remove and replace the existing scuppers with metal scuppers with magnetic latches
- Replace seven (7) existing doors, frames, hinges, with new heavy duty steel doors with magnetic latches similar to other existing doors

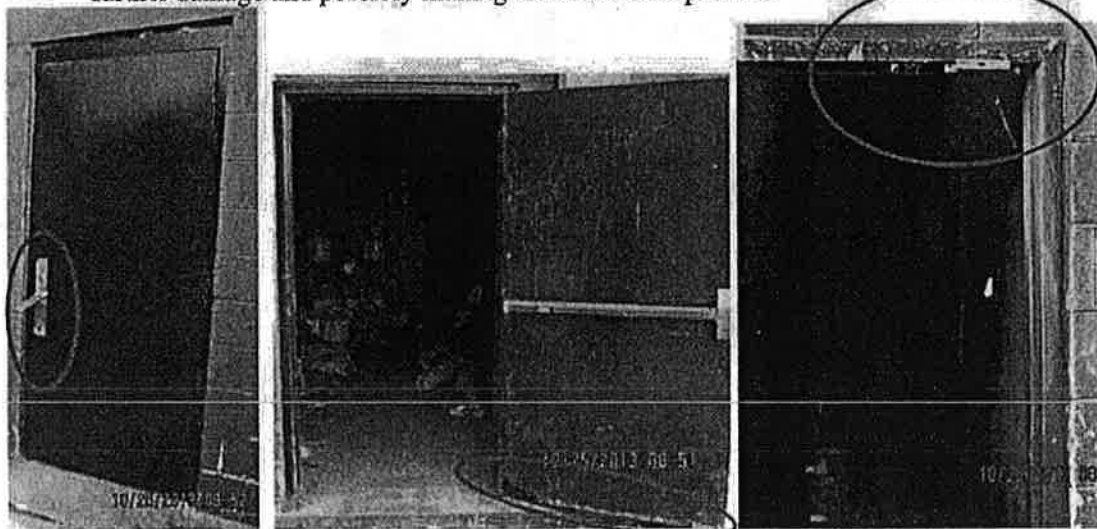
3. There are several damaged and deteriorated doors. Some of these doors have rotted jambs, rotted doors, and others have damaged hardware. These doors could pose an access or egress problem during exercises. Some of the doors stick and are difficult to open. The hardware for some of these doors is worn. Some of these frames these doors are subject to impacts from the fire fighters and equipment during exercises, which will further damage and possibly making these doors inoperable.

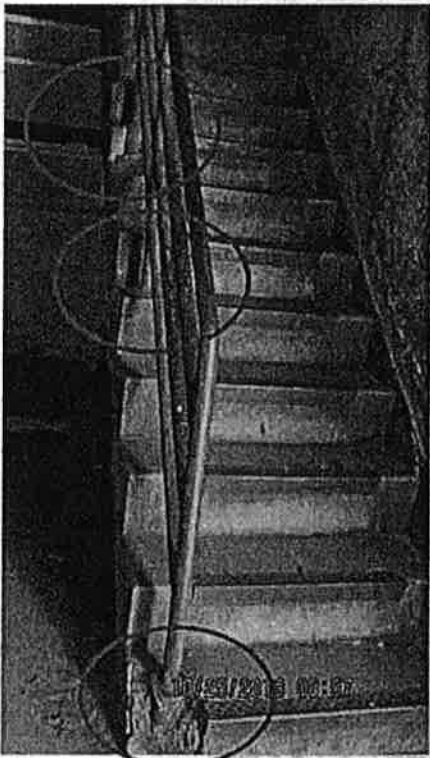
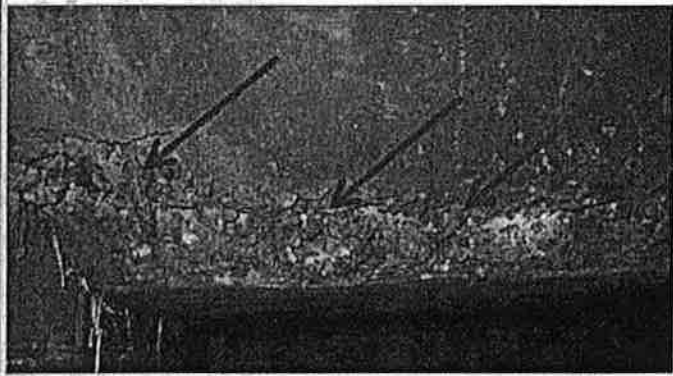
4. The internal front staircase has concrete damage where the railing is attached, and rebar is exposed in areas underneath.

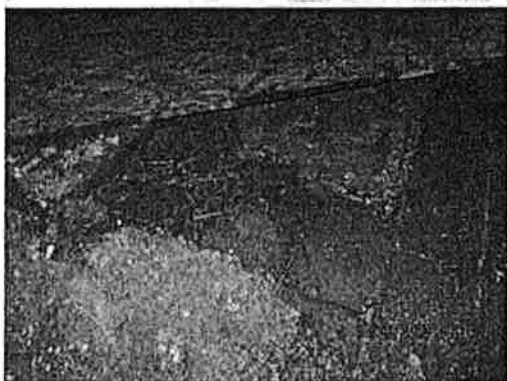
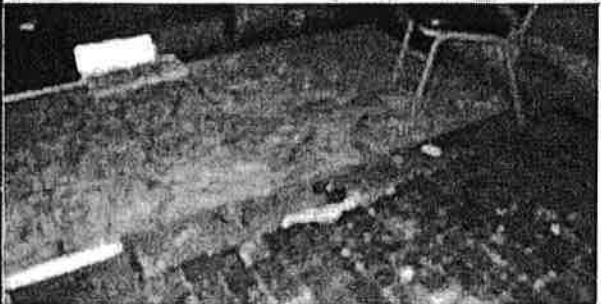
5. Some of the heat tiles within the burn rooms is damaged. There may be additional damage to the concrete floors and walls.

- Perform the necessary heat tile maintenance to the System 203, and/or 203 Lite, thermal lining system(s)
 - Included as part of the maintenance tightening the system and refilling bolt hole packing, and repacking joints that are filled with cast in place refractory mortar. Tile and insulation is not included.....\$3,556
- Repair the cracks in the concrete floor beneath the heat tiles
 - Cracks in the concrete floor of Room 202 be routed and sealed
 - Install a setting bed be installed below new fire pavers to achieve drainage in that room
 - The new fire pavers would be medium duty and would measure 4.5" x 9" x 1.25"
 - The minimum thickness of the setting bed would be 1"....\$4,950
 - Rollover protection over five exterior openings.....\$8,325

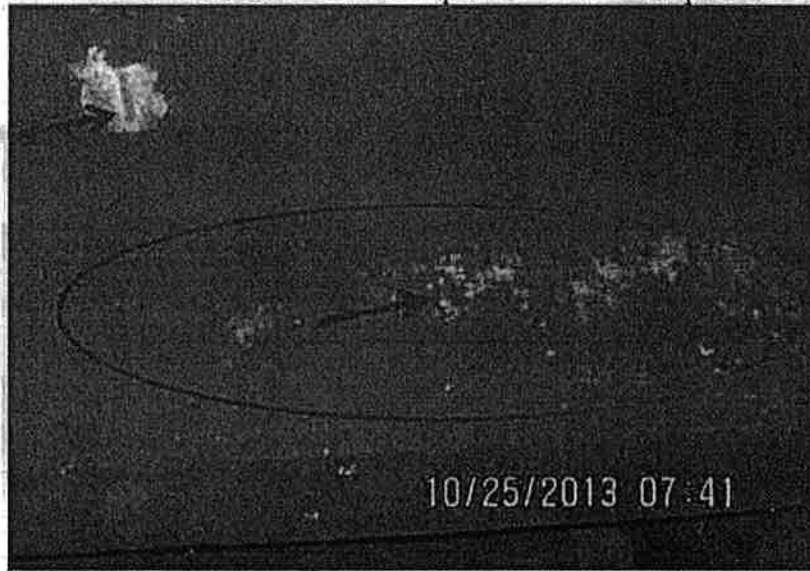
6. Some of the structural beams are spalled and rebar is exposed.

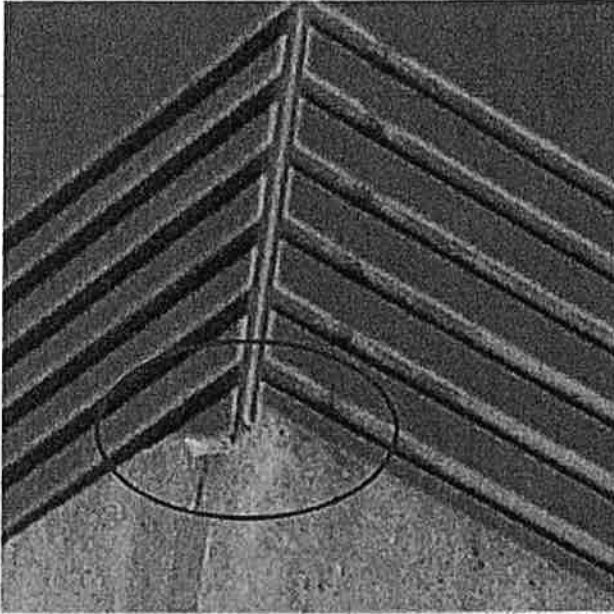
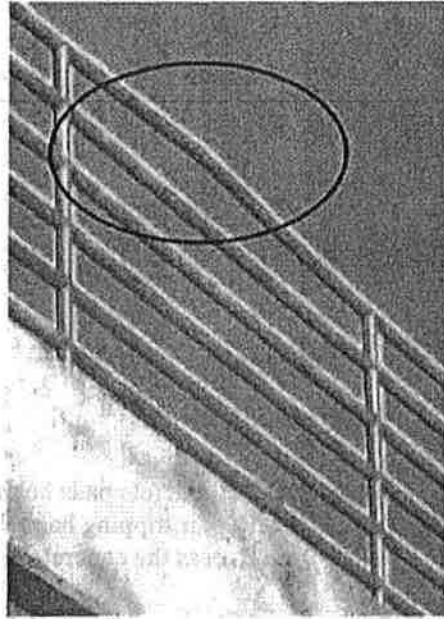
7. There are areas some areas of the safety railing where there is damage or the railing is bent. The railing is in need of paint.
