ATTACHMENT A
Burn Building Grant Application
Construction, Renovation, or Repair

Field Report

Subject: Repair Limited and Selected Areas of the Alexandria Fire Department Burn Building
per the The Structures Group Report and the job walks with Captain Jason Wehmeyer

Project Title: AFD-13-RFQ-002 Alexandria Fire Department Burn Building Repairs

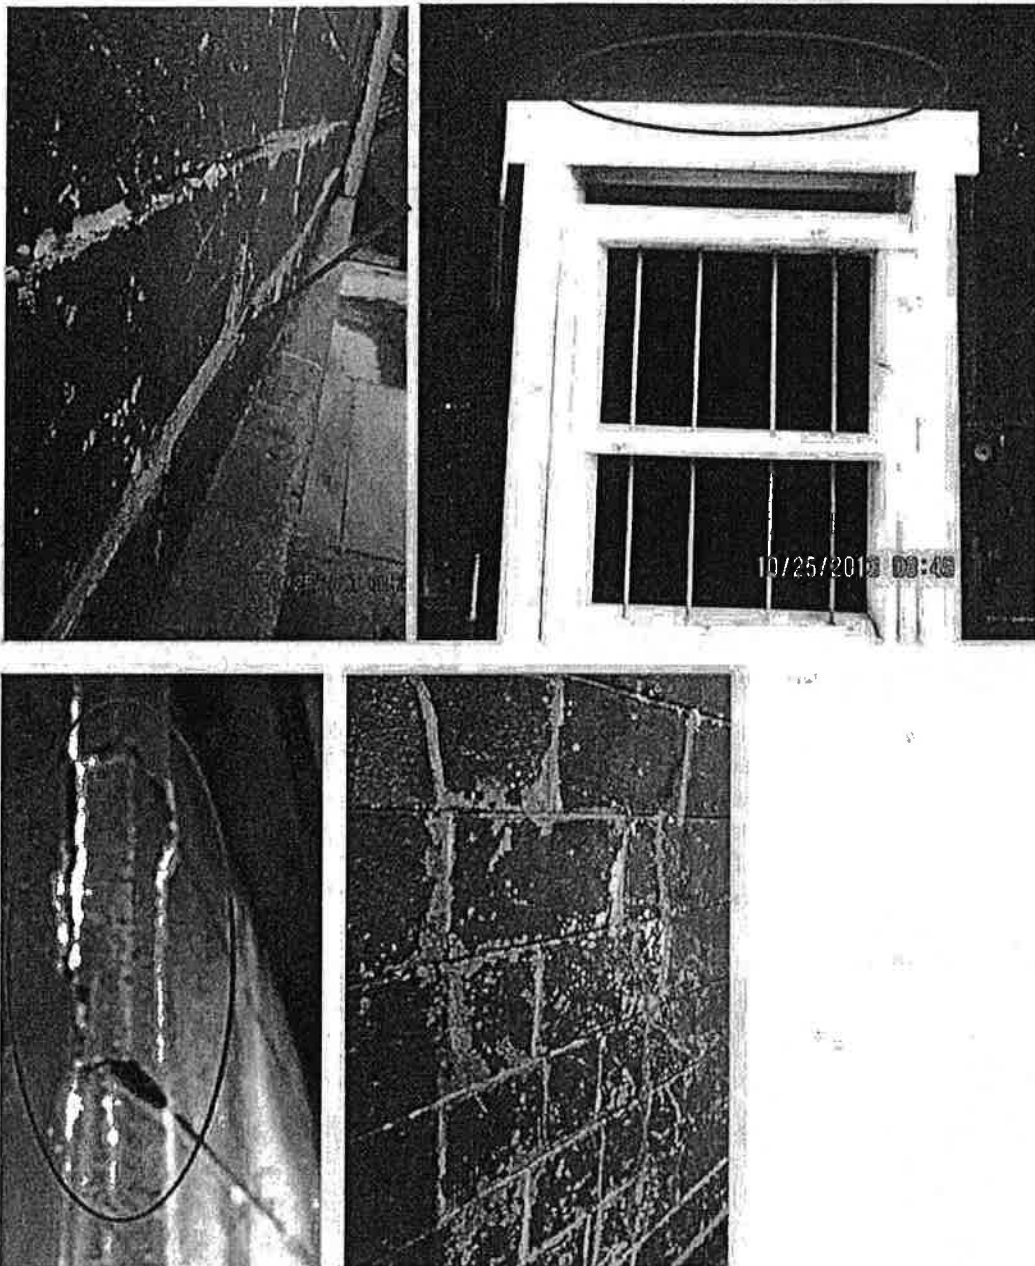
1. Some concrete masonry unit (CMU) walls are cracked and blocks have shifted. These walls are not load bearing, but during active water exercises, the cracks and shifted block will allow water to seep into the CMU and further deteriorating the structure. During freezing periods, the water within these blocks may freeze causing more cracks and wall shifting. Additionally, at least one lintel above a window was cracked.

- Repair the damaged masonry wall sections
 - Remove and replace broken concrete masonry units (CMU)
 - Remove CMU that are out-of-level
 - Plum exterior walls
 - Cracked mortar joints
 - Infill exterior doors being replaced
- Perform the necessary heat tile maintenance to the System 203, and/or 203 Lite, thermal lining system(s)
 - Included as part of the maintenance tightening the system and refilling bolt hole packing, and repacking joints that are filled with cast in place refractory mortar. Tile and insulation is not included.
- Repair the cracks in the concrete floor beneath the heat tiles
 - Cracks in the concrete floor of Room 202 be routed and sealed
 - Install a setting bed be installed below new fire pavers to achieve drainage in that room
 - The new fire pavers would be medium duty and would measure 4.5" x 9" x 1.25"

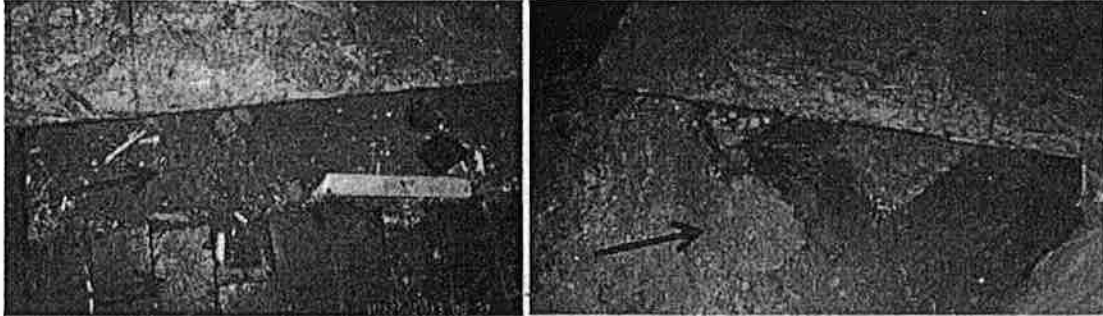
6. Some of the structural beams are spalled and rebar is exposed.
